HISTORIC STRUCTURES REPORT

BRICK WALKS

WILLIAM HOWARD TAFT NATIONAL HISTORIC SITE

Mark A. Chavez, Regional Historical Architect

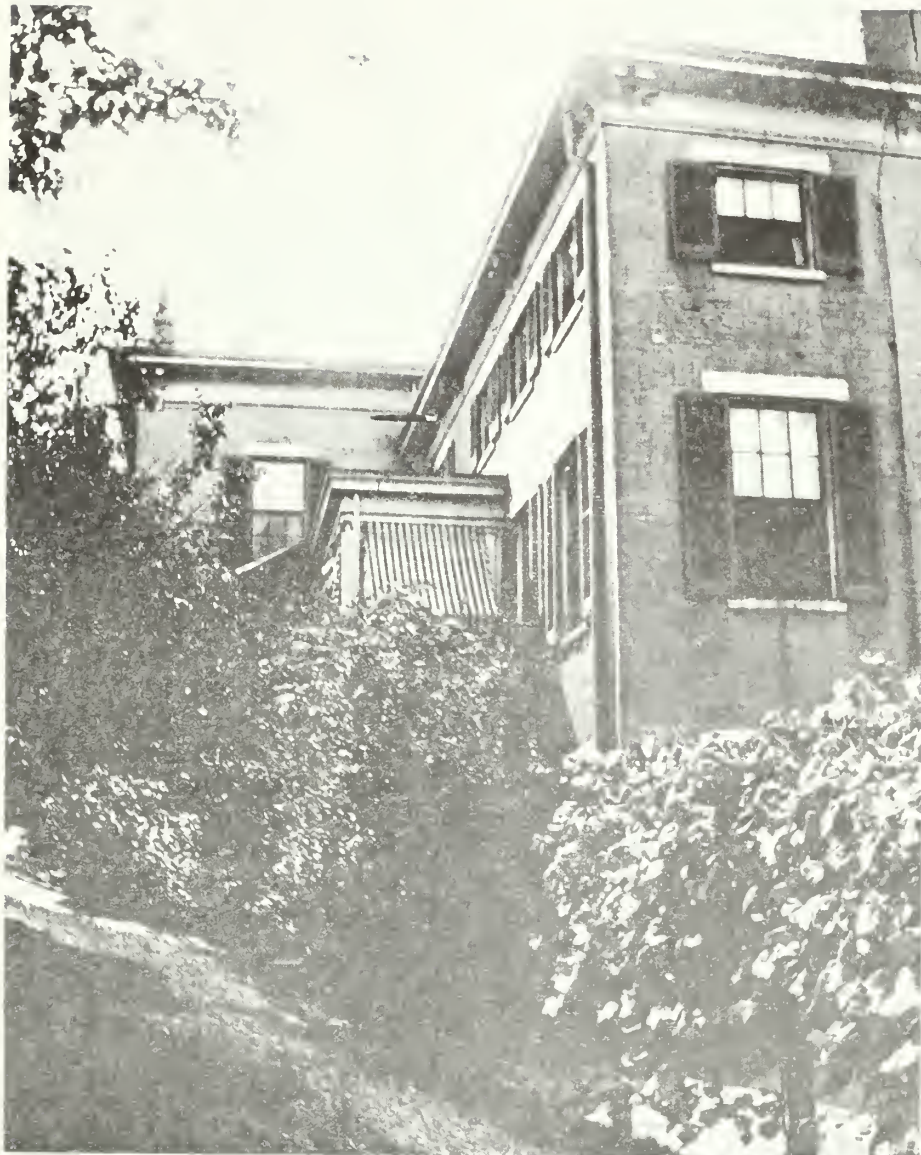
FIGURE 3.1

ANALYSIS: McCollough states this particular section of brick paving once belonged to a "large paved area at the southeast corner of the house." As can be seen in Figure 3.1, this "paved area" can be seen as a continuation of the "areaway" under the piazza along the south side of the house. All of the paving in this area was removed during the 1974 restoration and subsequent foundation and drainage work around the Taft home. Only the "areaway" has been restored. No evidence of the "larger paved area" was found, according to McCollough--except for the photo of the southeast corner (Figure 3.1).

Of interest in this photograph is the section of brick paving seen in the lower right corner. It is this paving which, according to McCollough, Bauxar, and Perry, formed an extension of the south areaway possibly leading eastward to the privy.

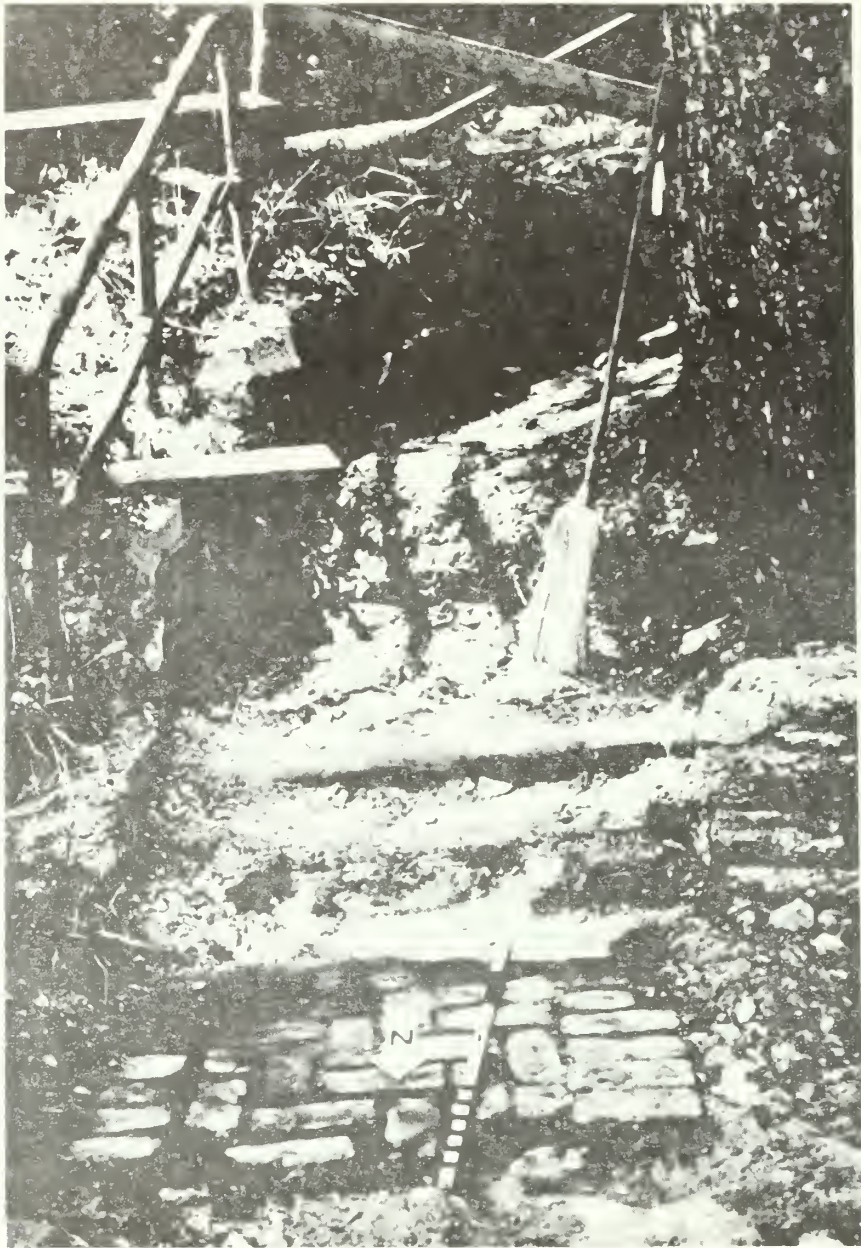
FIGURE 3.2

During archeological investigations for the 1974 restoration, the concrete walk seen in Figures 3.4 and 3.5 was removed, and the ground beneath the sidewalk (shown wrapping around the tree) was excavated in hopes of finding remains of a brick walk which may have connected steps in this area to the historic piazza. The results were negative.

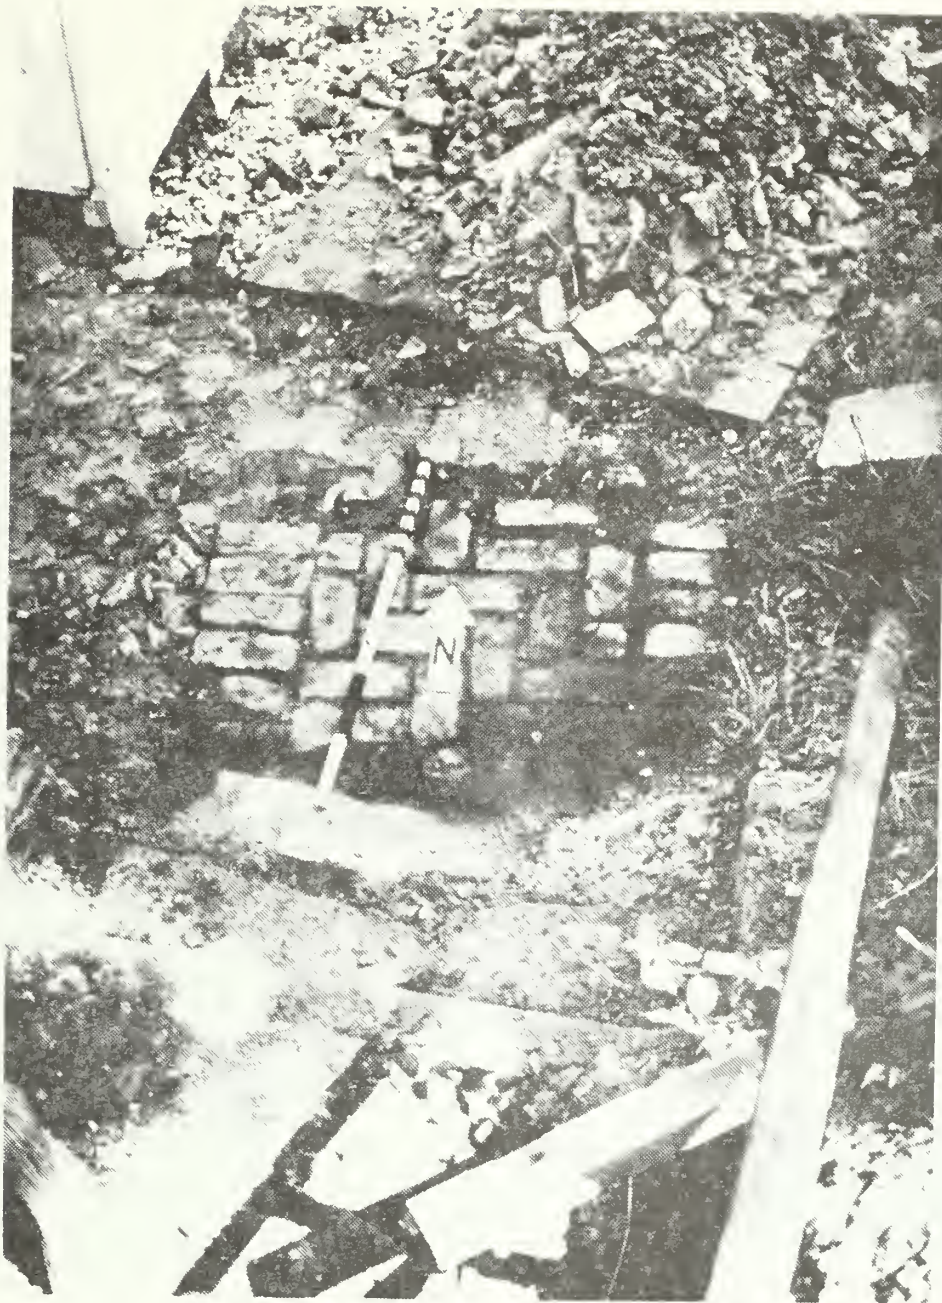
FIGURE 3.3

According to Perry, this section of walkway was non-historic, due to the type of brick used and the pattern (the historic paving had a different edge detail and was set at a diagonal herringbone versus the ninety-degree herringbone pattern seen here). Beneath this paving OhXuxar discovered historic paving (see Figures 3.21 and 3.22).

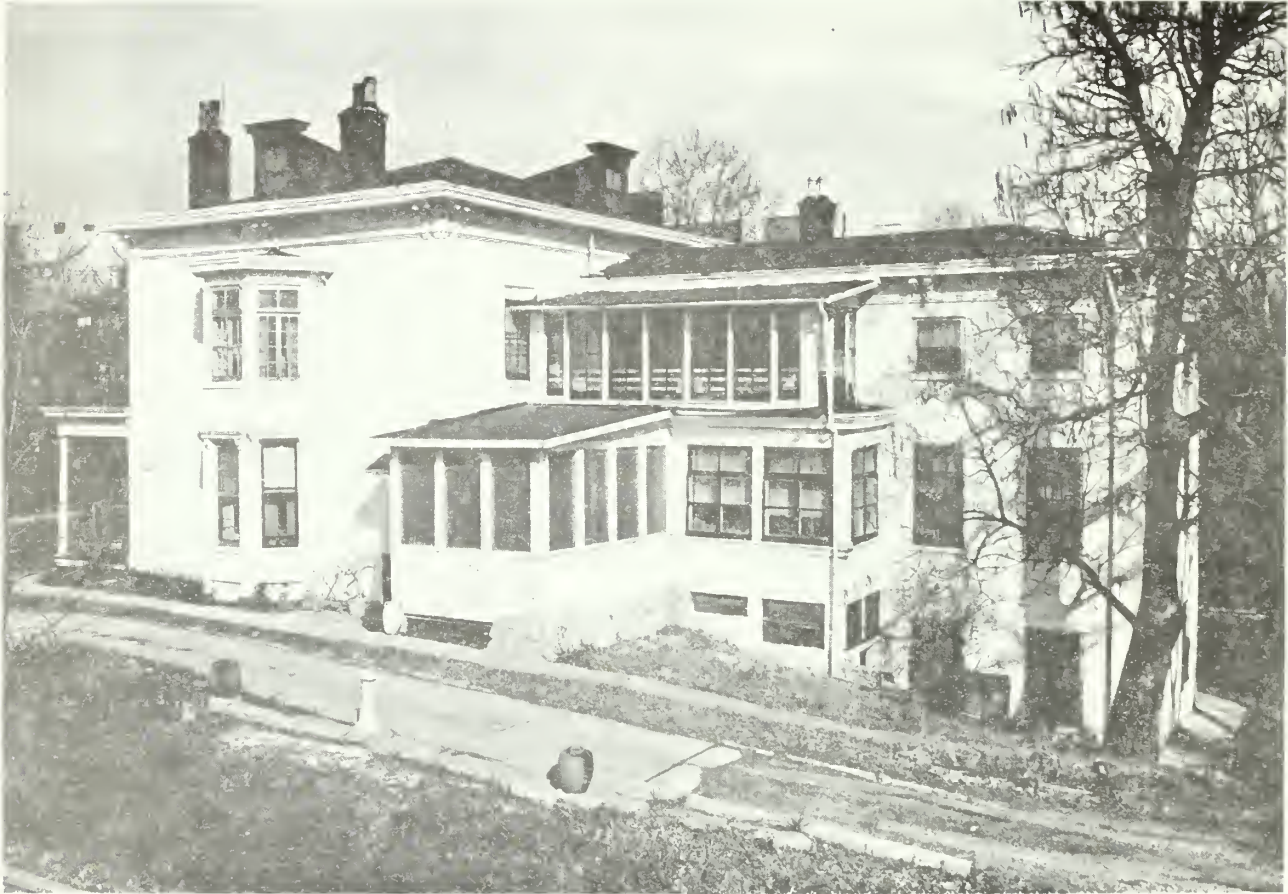
FIGURE 3.4

This photograph shows the non-historic south porch, and solarium. The concrete sidewalk leading around the south side from the front can be attributed to Elbert R. Bellinger, who owned the home from 1940 to 1960. Two layers of non-historic brick paving were uncovered (see Figures 3.7 and 3.8) when a portion of this walk was taken up during the 1974 restoration.

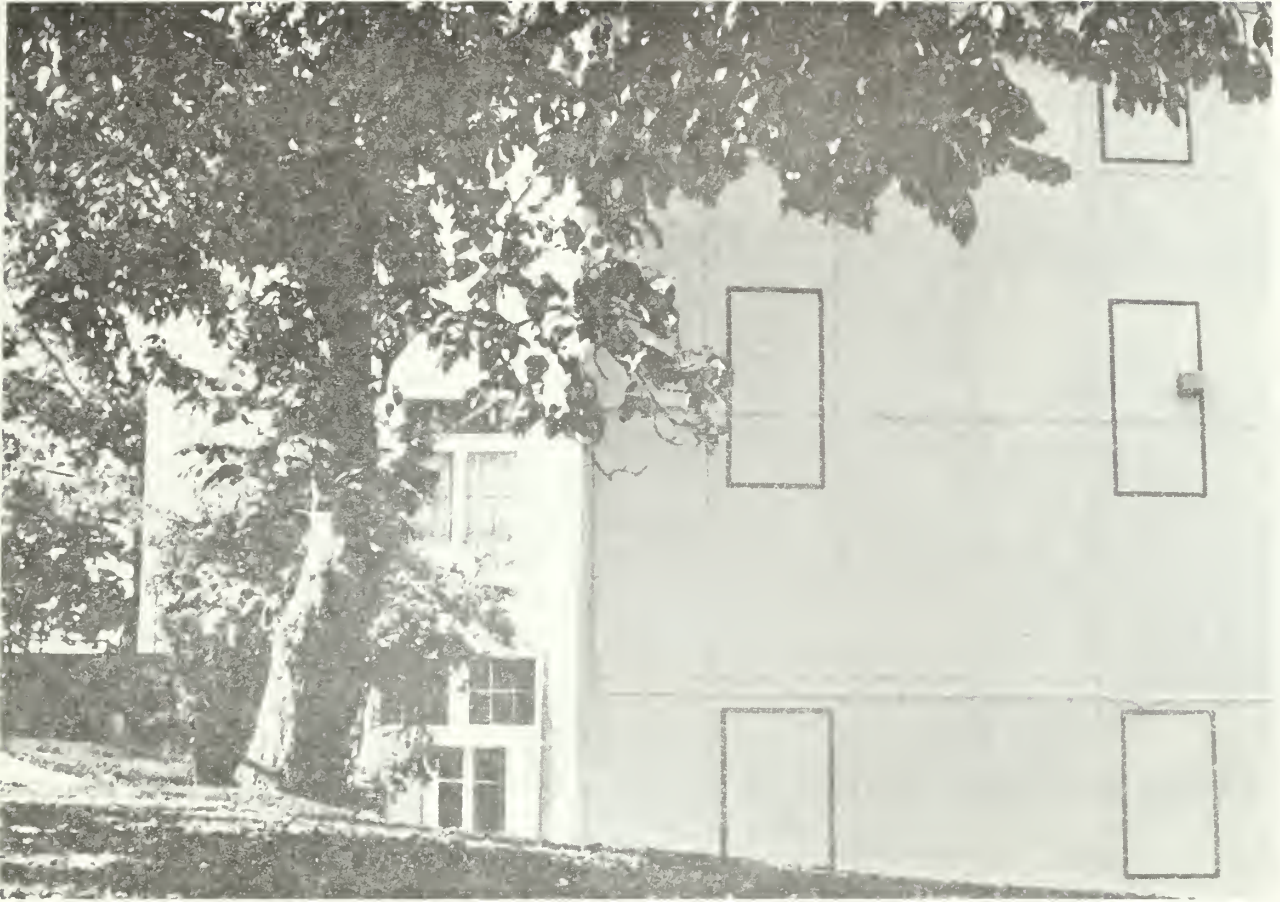
FIGURE 3.5

The concrete walk seen at the very south edge of the Taft home in Figure 3.4 terminated in a set of stairs (the handrail of which can be seen just in front of the tree) which led down to the level of the basement. Both the walk and stairs are attributed to Bellinger and are non-historic.

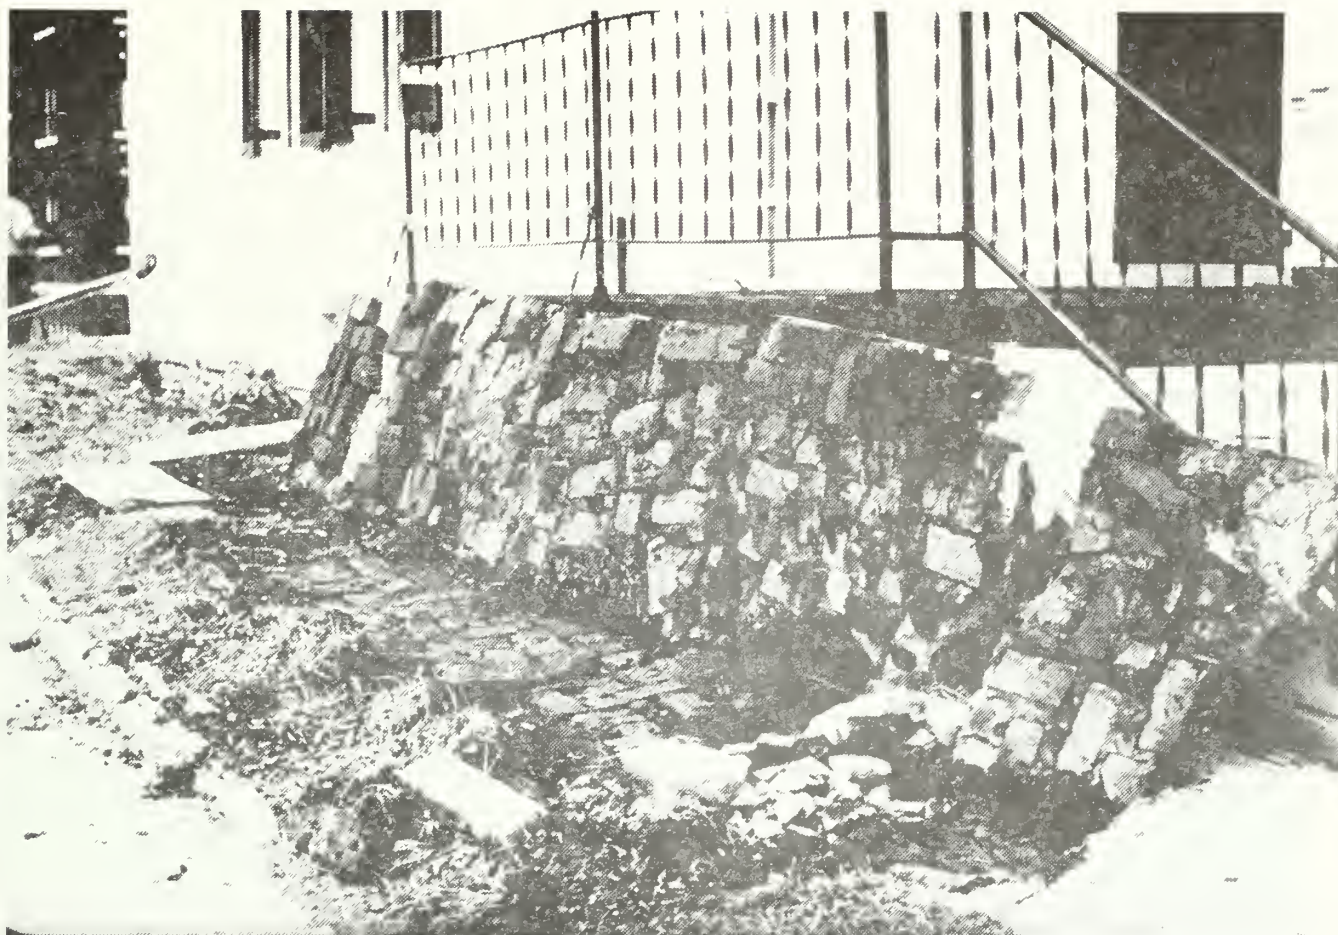
FIGURE 3.7

Both layers of brick, according to Perry's analysis, were of a much later (early 1900s) variety than those attributed to the Taft occupation. Historic pavers were not located beneath the two non-historic layers. Also, the historic walk would have been closer to the house (two feet, versus six feet as existed in this photograph).

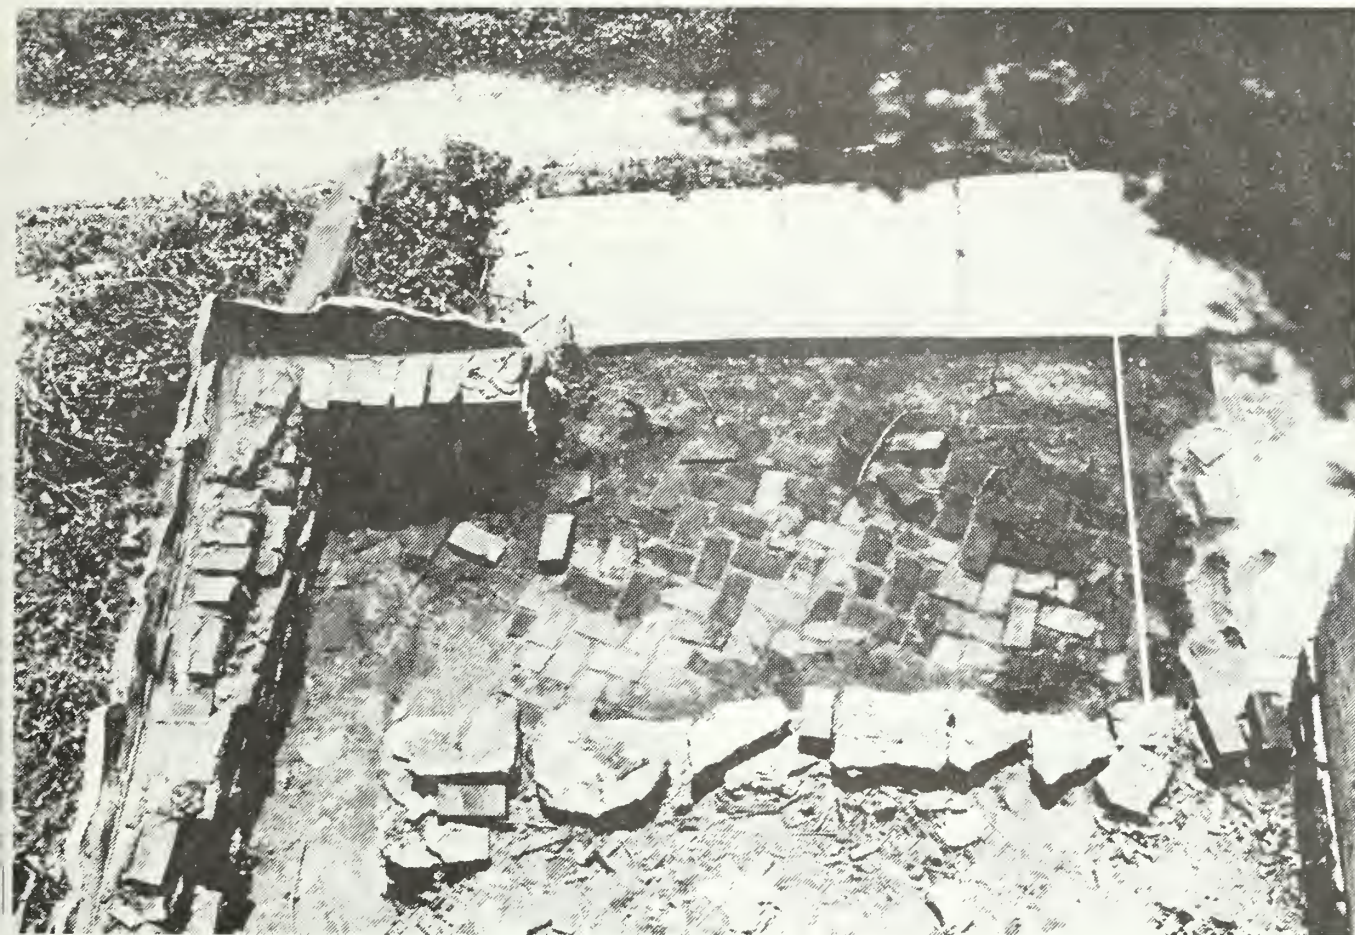
FIGURE 3.11

Note the herringbone pattern in the brick paving. This paving most likely was the continuation of the walk around the south side of the home.

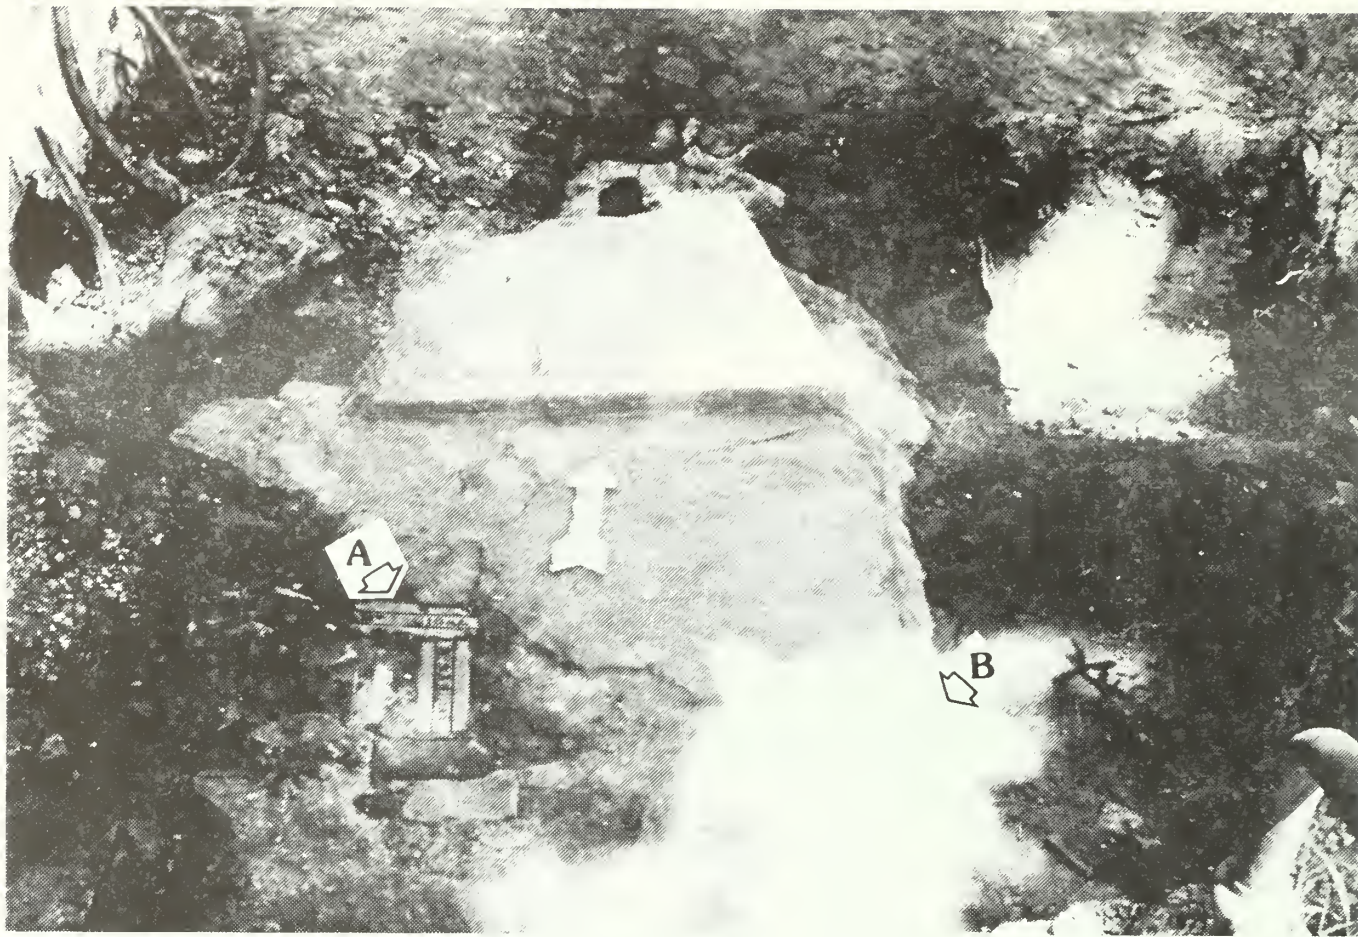
FIGURE 3.12

A) Non-historic McManigal pavers disclosed directly beneath the concrete walk.

B) McCollough assumed the paving edge pointed out here (which shows up in Figure 3.13) belonged to a continuation of the brick areaway along the south side of the house at basement level. Bauxar's subsequent investigations proved McCollough correct. The type of brick and the pattern match the historic paving discovered elsewhere.

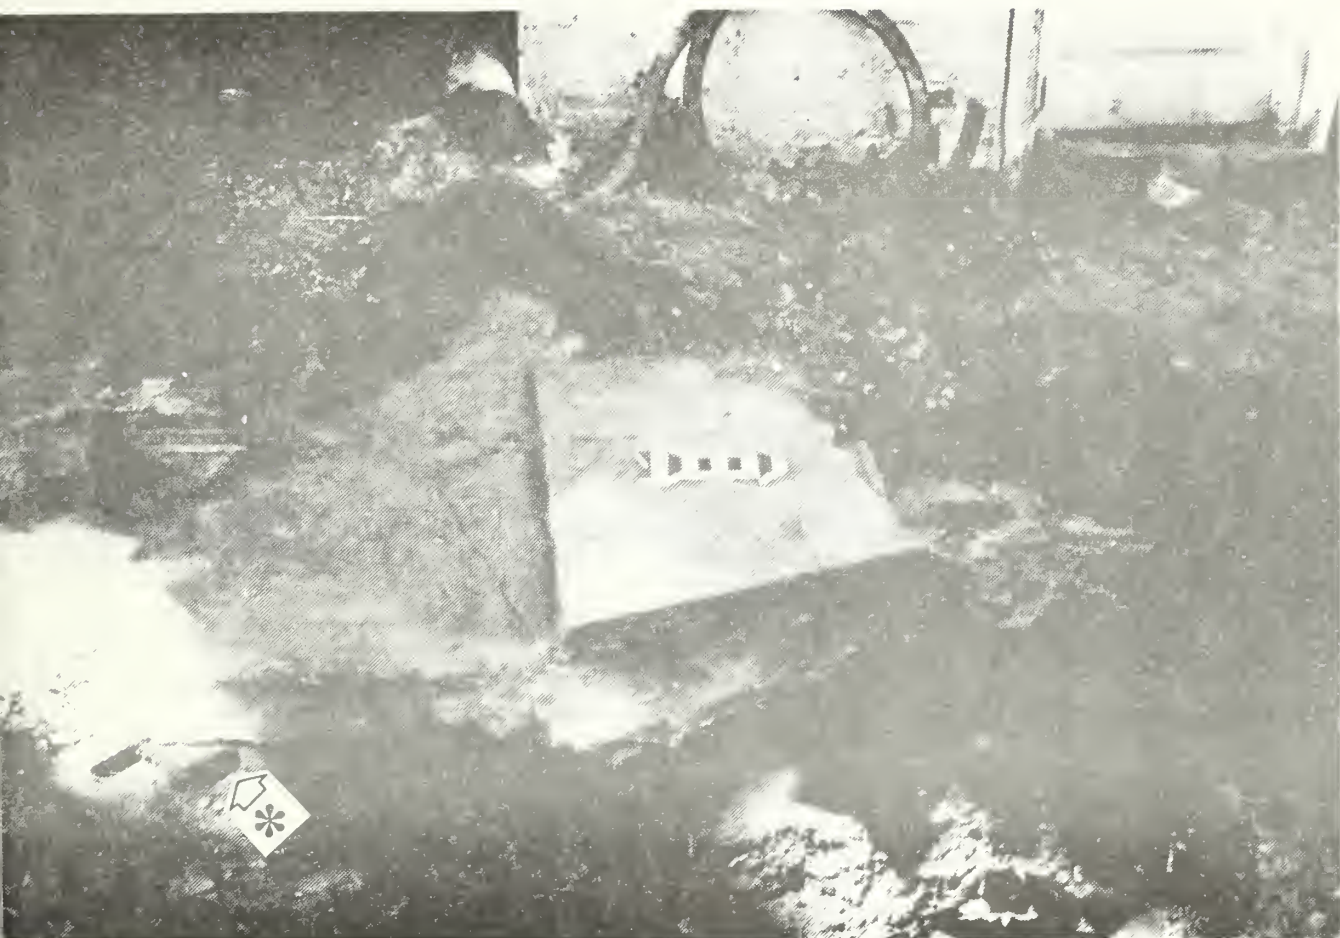
FIGURE 3.13

Edge of historic brick paving uncovered during the McCollough investigations. Note historic brick paving beneath concrete walk (at * arrow).

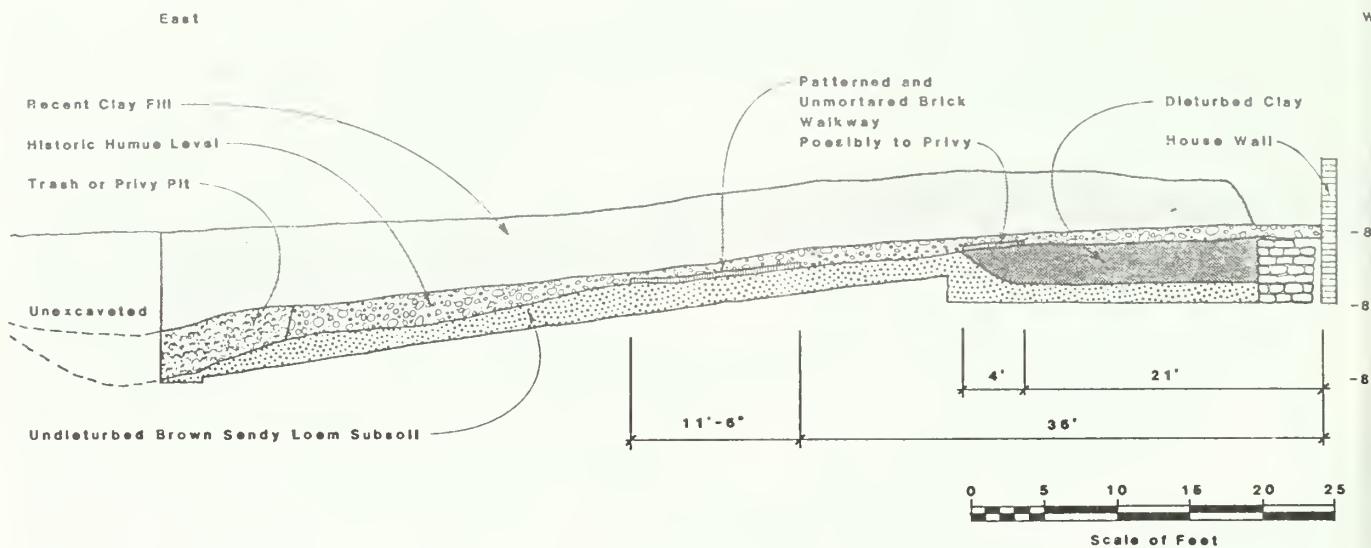
FIGURE 3.14

Note two sections of historic brick paving which, according to McCollough, belonged to the privy walk.

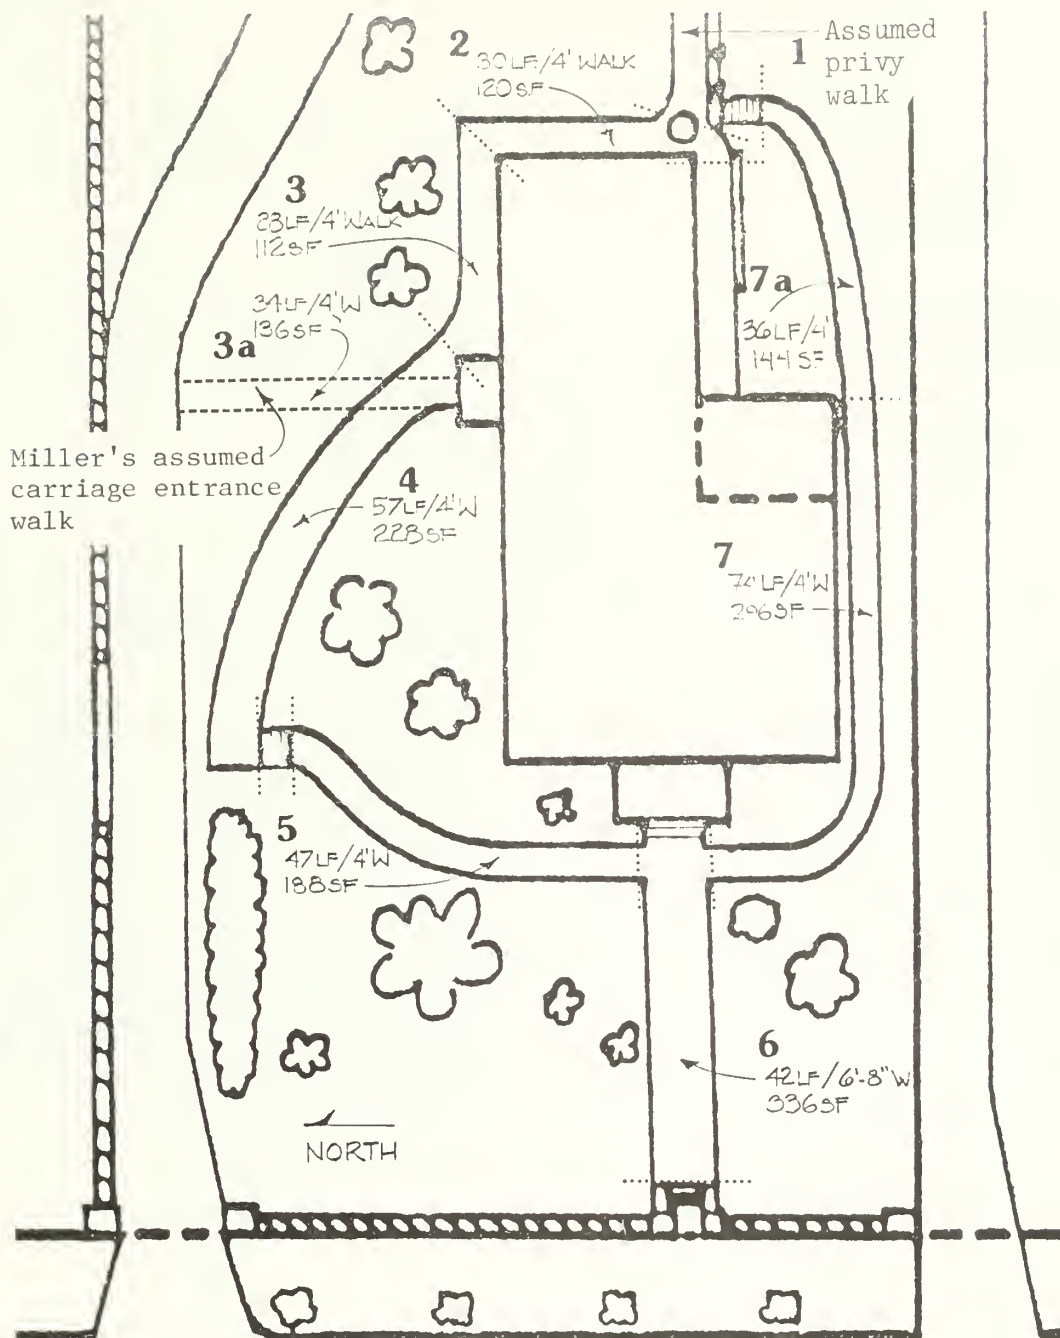
FIGURE 3.15

This detail shows the arrangement of brick walks McCollough assumed existed historically. The calculated areas approximate quantities of brick which may have been purchased by Hunt and Lull to pave walkways in October 1851 (refer to reference 9 on page 20). According to the historical accounts 2,600 brick were purchased at that time. The calculations on Figure 3.16 refute these calculations.

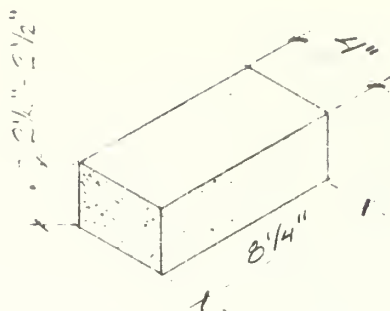
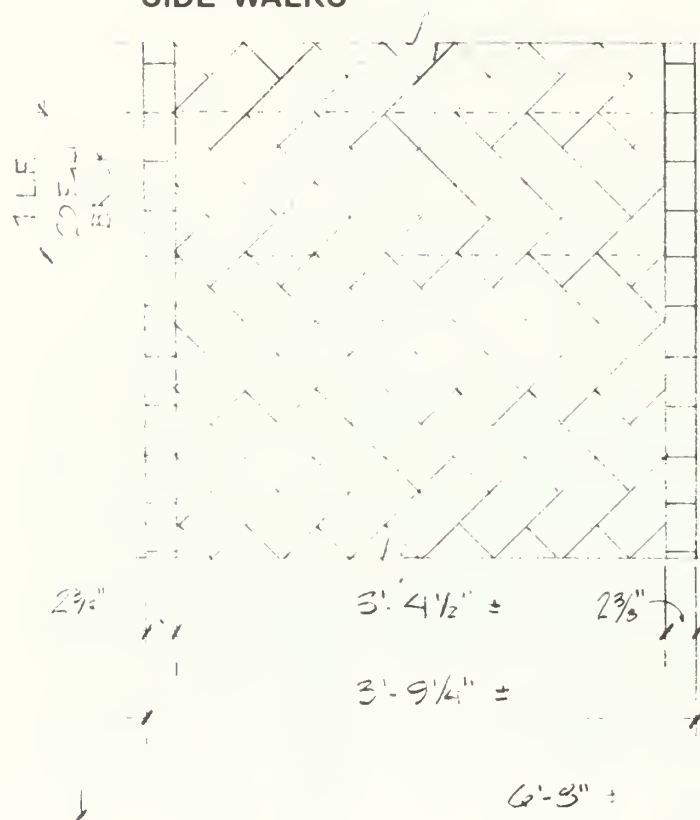
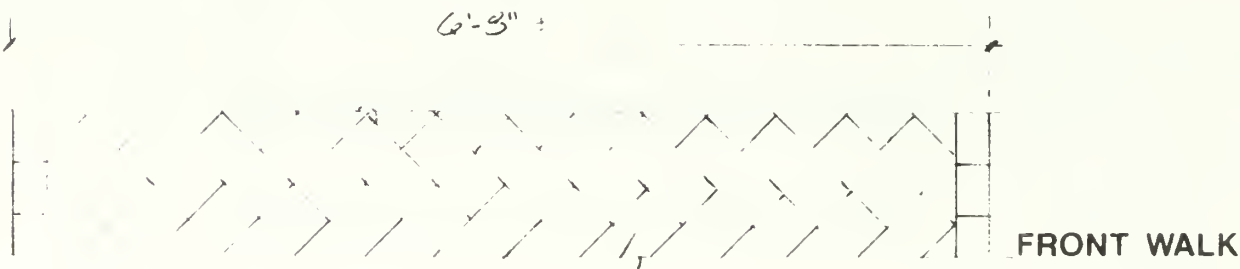
FIGURE 3.16

Based on Deborah Bauxar's findings, the size of the historic pavers were as shown at the left.

Using these dimensions, and allowing for minimal joint widths, a layout as shown at the left might have existed. The total width of the walk is approximately 3 feet, 9-1/4 inches.

One lineal foot of walk with the above width would have required approximately 20 brick, and the following walks would have required the accompanying quantities of brick:

#2--East (30 l.f.):	600 ea.
#3--Northeast (28 l.f.):	560 ea.
#4--North (57 l.f.):	1140 ea.
#5--Northwest (47 l.f.):	940 ea.
#7--South (74 l.f.):	1480 ea.
Total:	4720 ea.

The front walk (# 6), which was approximately 6 feet, 8 inches wide, would have required approximately 32-1/4 brick per l.f., or approximately 1355 brick total.

Using the above calculations, it is difficult to imagine how 1300 bricks could have been used to pave "behind and north and south of the house," since, to pave these areas (walks 2, 3, 4, and 7)--according to the above calculations--approximately 3780 brick would have been needed. Also, according to the above, the front walk would have required approximately 1355 brick, which is very close to the quantity listed (1300) which was said to have "finished paving the front walk."

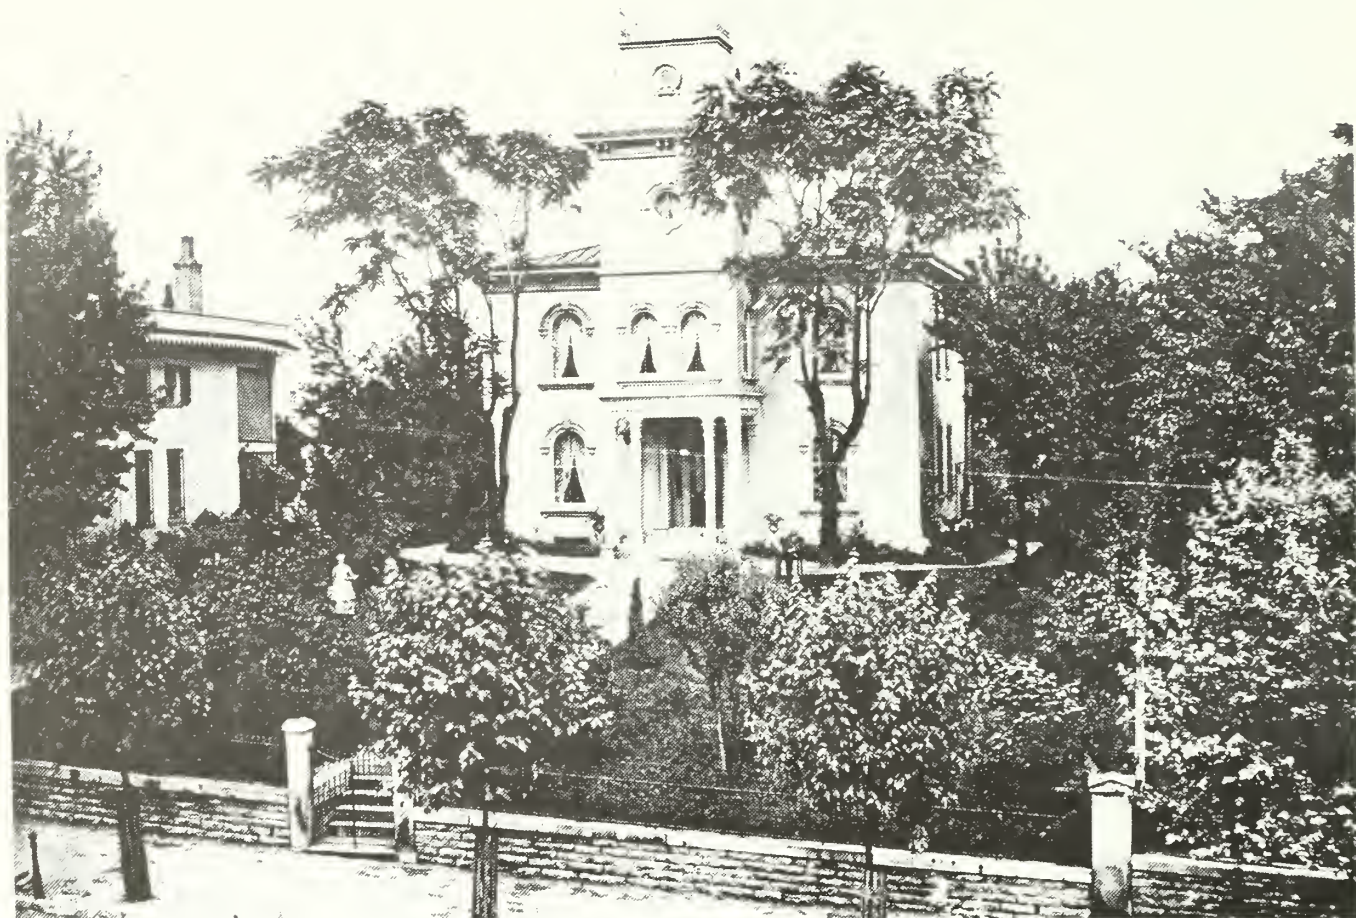
FIGURE 3.18

Note the brick walks leading to the front of the home and around to both the north and south sides of the home. Assuming it was common practice to take a brick walk around both sides of a residence as is the case with the Burkhart home here, we might conclude that a similar arrangement existed at the Taft home, although the sites are different.

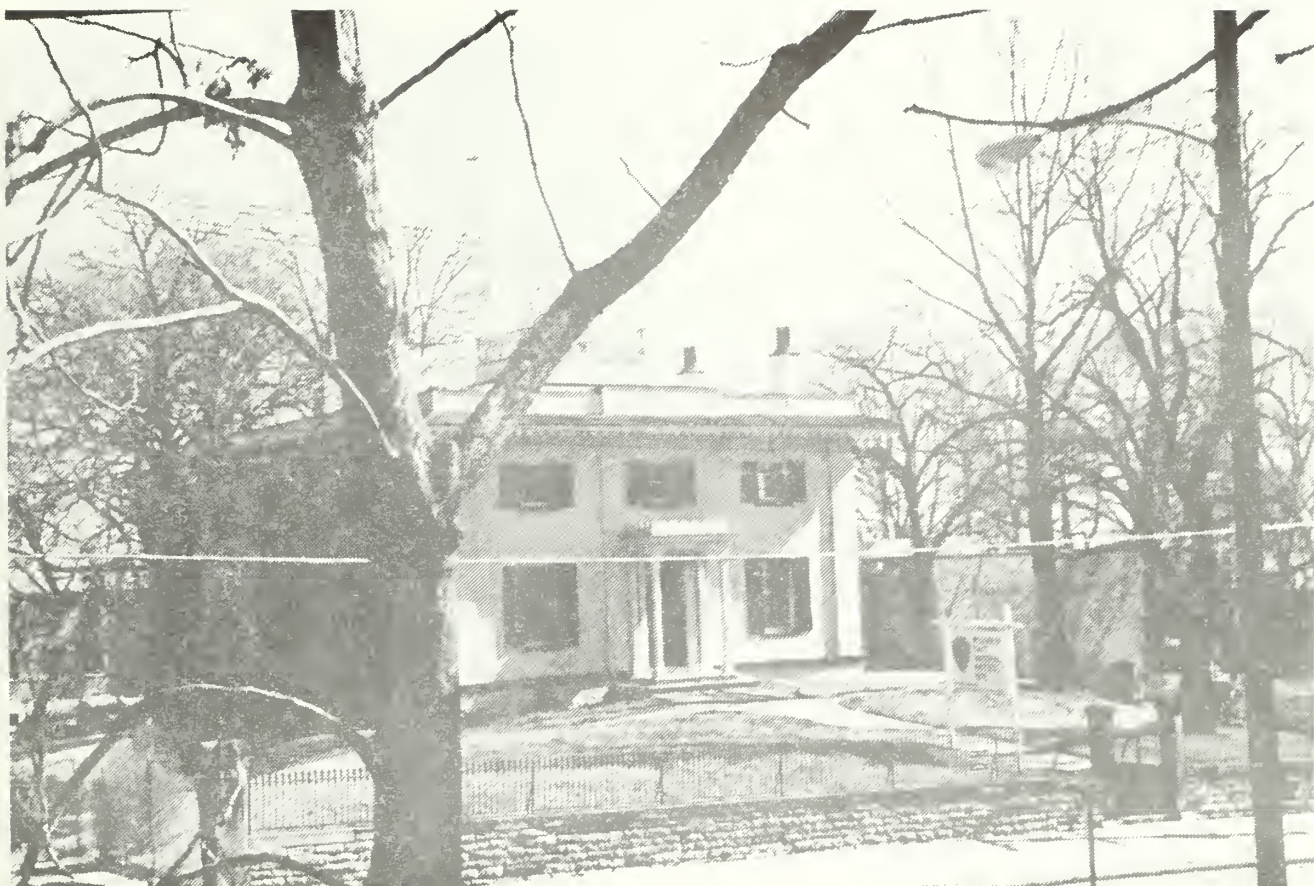
FIGURE 3.19

This contemporary photograph was taken to approximate the vantage point of the historic photograph shown in Figure 3.9. Of primary interest is the fact that the modern concrete sidewalk leading to the north can just barely be seen. This might indicate that a similar condition existed historically: A brick walk led north from the main entrance walk, but was hidden behind a small berm of earth and grass.

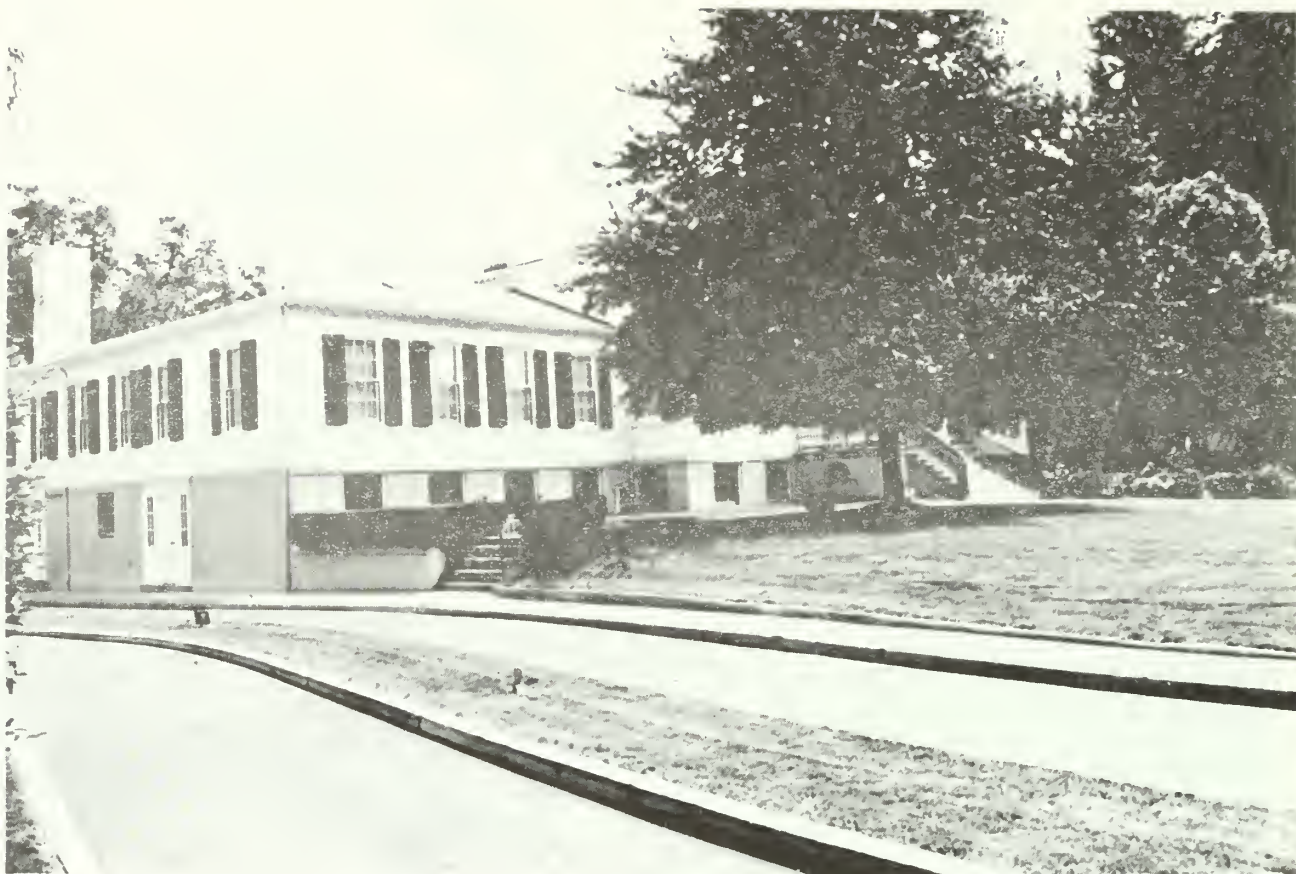
FIGURE 3.20

ANALYSIS: Miller's assertions are correct: There is no precedent to assume that the curving walk which shows up on the McCollough drawing (and which exists presently in the same location) was installed to replicate a historic walk in the same location. As stated earlier, such a walk seems logical for convenience sake, for access to the north and east sides of the home. A possible assumption is that when the historic walks were replaced with modern concrete that the placement and configuration of the new was exactly as what existed historically, as was the case in the discoveries at the back (east) of the house. However, there is no evidence to back this assumption up. Any location or configuration will be entirely conjectural. Ground investigations in October 1986 along this north walk did not reveal additional information. A recent (June 1987) photograph of the Taft museum (see Figure 3.20) really does not support Miller's assertion. It is very

This photograph was taken to compare possible carriage entrances in support of William Miller's assertion that a similar condition existed at both this site and the William Howard Taft National Historic Site property. The conclusion is that the sites are indeed different, and the entrance viewed in this photograph is a modern addition.

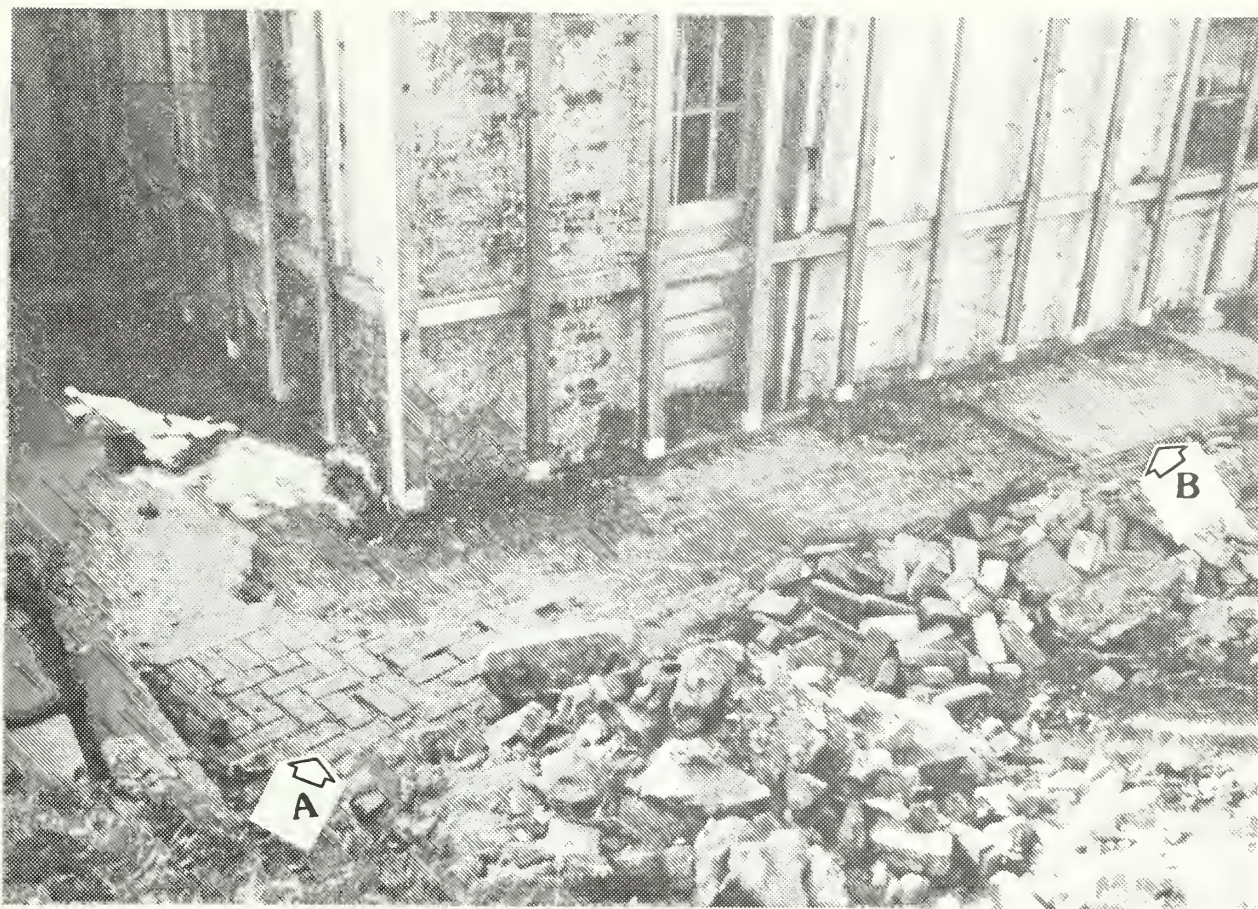
FIGURE 3.21

A) Another view of the paving seen in Figure 3.3.

B) Beneath the paving shown at "A" was a layer of historic paving, similar to the section which is seen about six feet north of the east door. Note that there would have been at least one step down from this door to the walkway. Figure 3.22 is a detail of this area.

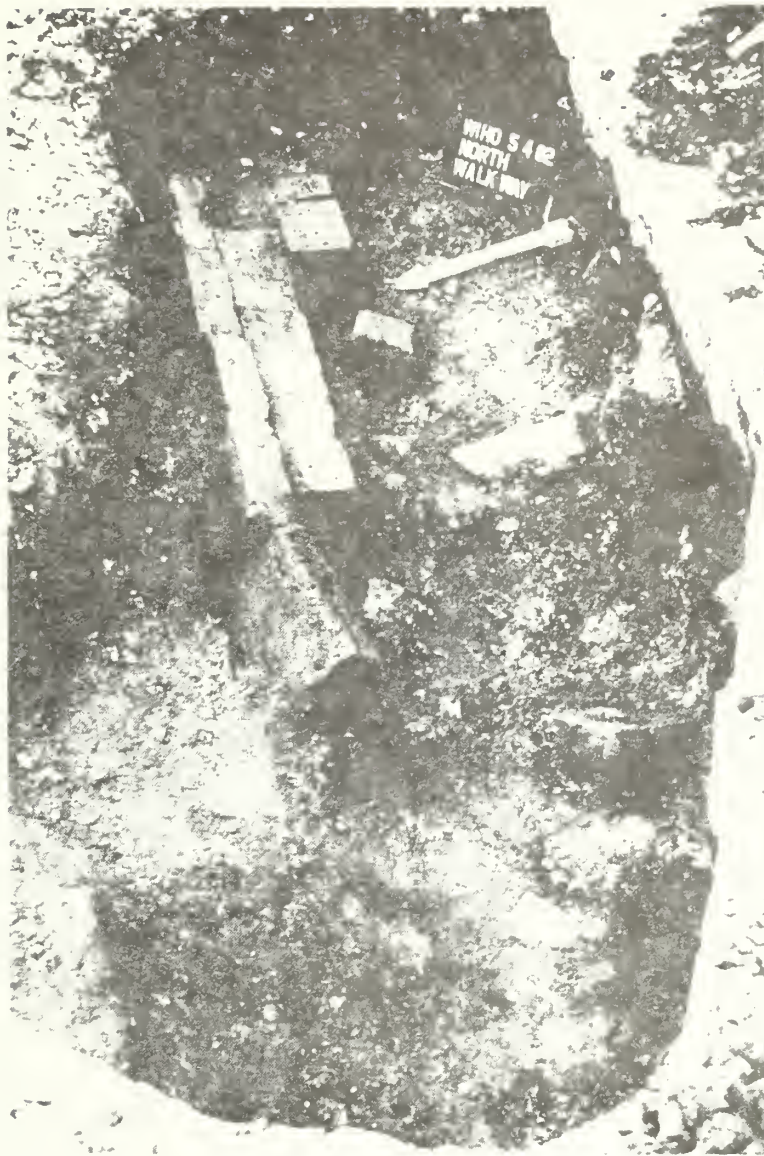
FIGURE 3.26

The brickwork seen in XU 6 (Figure 4) [see Figure 3.26] was disrupted by the construction of the east wing and again by the installation of plumbing during the 20th century (McCollough 1971). To the west of the unit in Shovel Probe J, portions of two or more broken ceramic sewer pipes intruded. The earlier brickwork ended abruptly, on the east side, probably as a result of earlier excavations (Bauxar 1975; McCollough 1971:25). To the south, the contemporary sidewalk and the north foundation of the east wing disrupted the earlier brickwork. These disturbances explain the mixture of 19th and 20th century materials observed in the cultural zone.

This paving, as noted by Perry, was not historic due to the type of pavers "street pavers similar to the MacManigal pavers, set in concrete." Also, the pattern is common bond rather than diagonal herringbone as is the case with the historic paving.
